## REPORT OF BUILDING PROJECTS OFFICER

### **SUBJECT : CAREW MILL & CAUSEWAY – RESERVOIRS ACT STATUTORY REPAIRS**

## CAREW MILL AND CAUSEWAY REPAIRS

### Outline Method Statement

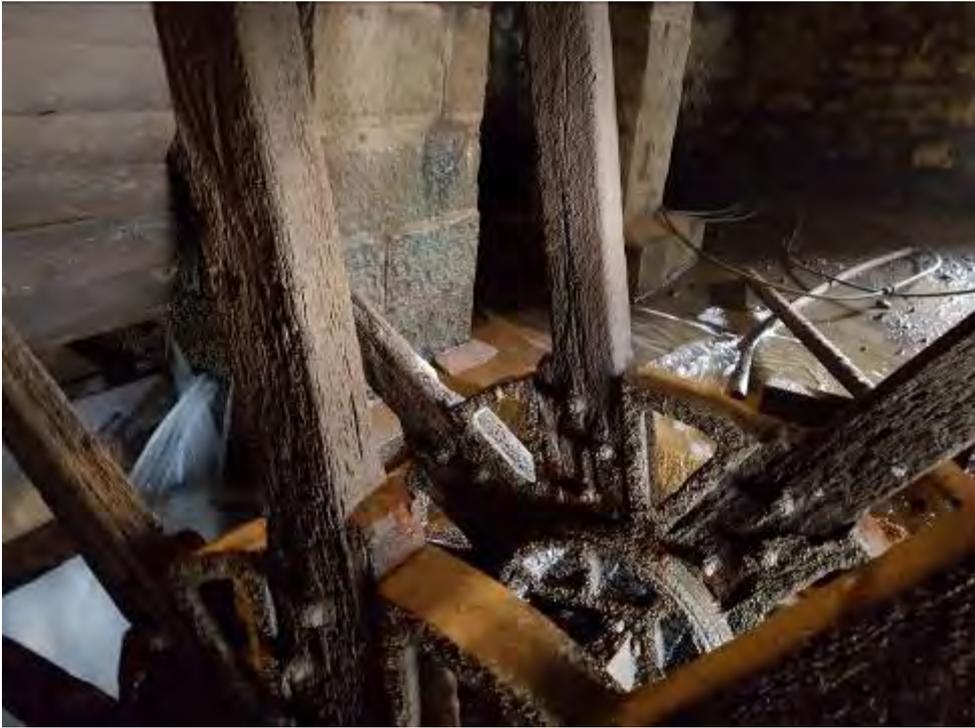
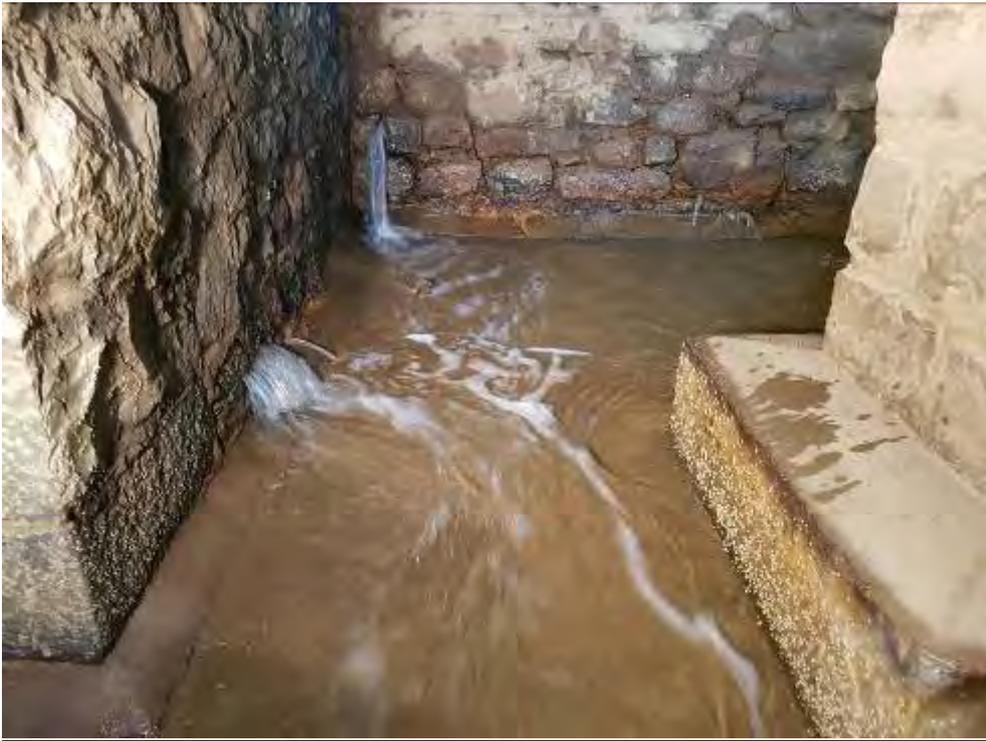
The works required to prevent leakage into the wheelhouse form the most substantial element of the repairs required. Works to prevent leakage within an old masonry dam structure with limited space for the works is challenging and requires specialist geotechnical engineering techniques to remediate. A particular difficulty is the use of concrete grouting where high flow velocities through leaking sections of wall as a result in variations in water levels between the upstream and downstream side of the dam. This can result in washout of grout materials before they can set. This problem can partly be mitigated by draining down the (upstream) pond to reduce the flow of water through the dam structure, however it is not anticipated that measures would be taken to prevent the natural variation of tidal levels on the downstream side of the dam.

Limited grouting repairs were carried out in 2002, using cementitious grout to infill voids around the sluice tunnels for both the north and south mill wheels and to the seaward facing dam wall immediately to the west of the Mill House. These repairs have been successful in reducing leaks, but due to the limited extent of the repairs and the passage of time, seepage between the flap channel and the mill building has increased in recent years and there is a need to undertake a further phase of work in the vicinity of the mill.

Photos showing leakage into the Wheelhouse (Basement)

Atkins has investigated a number of options to reduce the leakage within the causeway, based on a range of construction techniques. This includes an option for resin grouting which has been successfully used to repair old dock walls at Milford Docks even whilst the docks remain in operation. In addition, conventional grouting of the ground has been considered as well as removal and replacement of the impermeable clay core material. The design of the repairs has had to consider sub-surface flows of water which continue to cause erosion as well as repointing repairs to wall masonry. All the options proposed have been costed and compared and will be selected to deliver both an economic solution and one which utilises construction methods sympathetic to the conservation value of the Causeway.

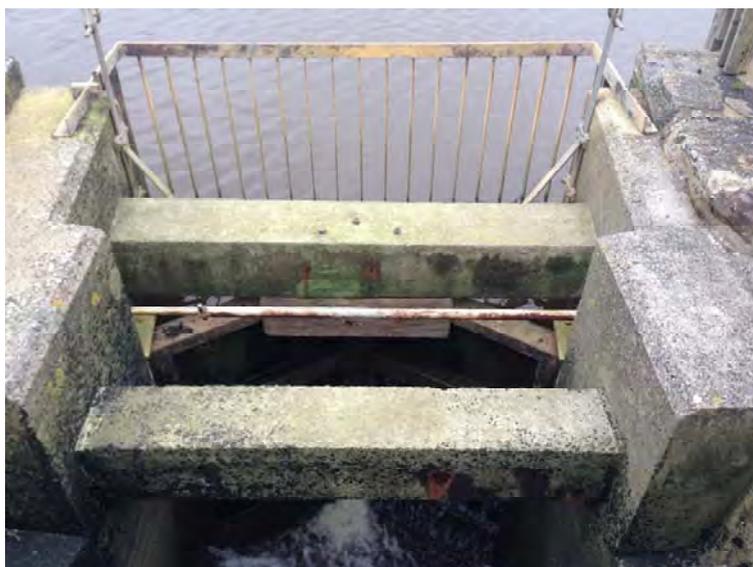
**Photo 1- View of sluice gates within the sluice channel (sited below the concrete beams)**

1. Remove temporary disabled access ramp to the Mill Shop.
2. Access the gate location, via the causeway with a small excavator, Hiab (road going crane-lorry).
3. Remove the fixings retaining the gate in place (**see photo 1**)
4. Lift out the gates with the excavator or Hiab and place on transport.
5. Install stoplog retaining channels (steel rails fixed to walls).
6. Install stoplogs.

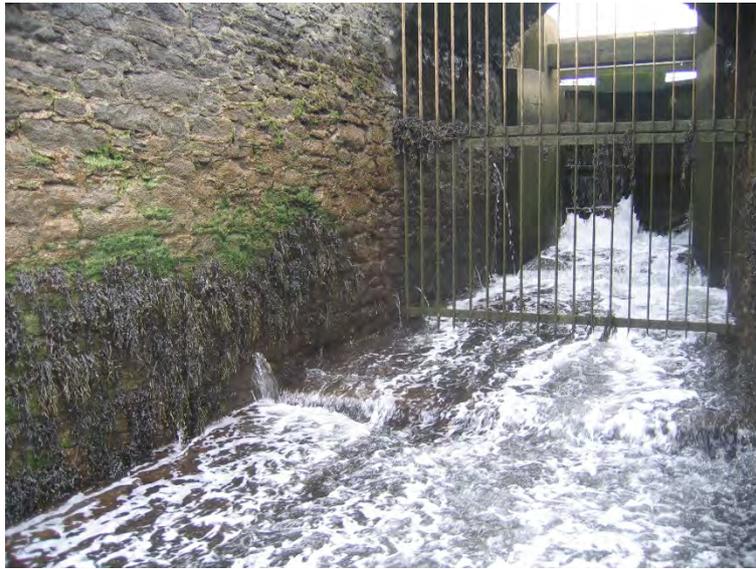
**Photo 2- View of sluice channel looking upstream towards the sluice gates**

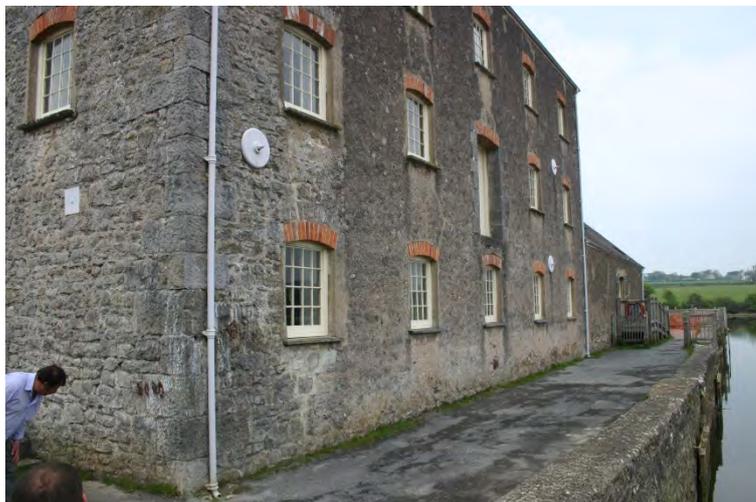
**Photo 6 – View of causeway, footpath and Mill House (with disabled ramp in background)**

Will involve placing concrete or grout within the core of the causeway itself. All the works will be below ground and carried out from the causeway itself. All surfacing material will be reinstated in completion – see **photo 6**.
