## REPORT OF BUILDING PROJECTS OFFICER

### **THE CAUSEWAY, CAREW MILLPOND AND CAREW CASTLE PROGRESS REPORT**

### **SUBJECT : CAREW MILL & CAUSEWAY – RESERVOIRS ACT STATUTORY REPAIRS**

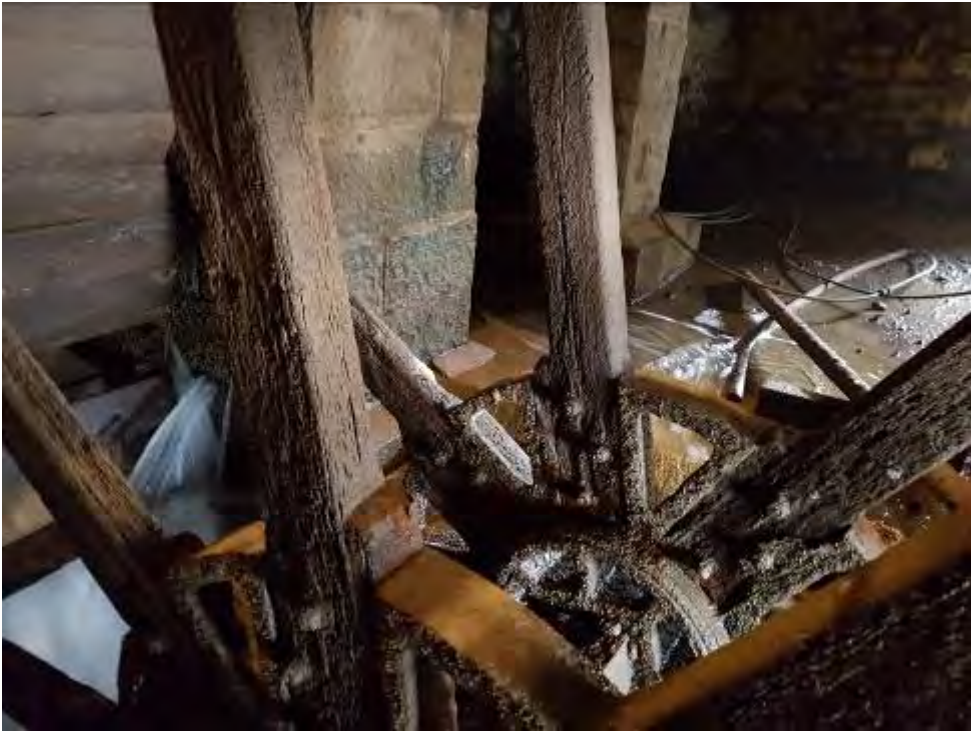
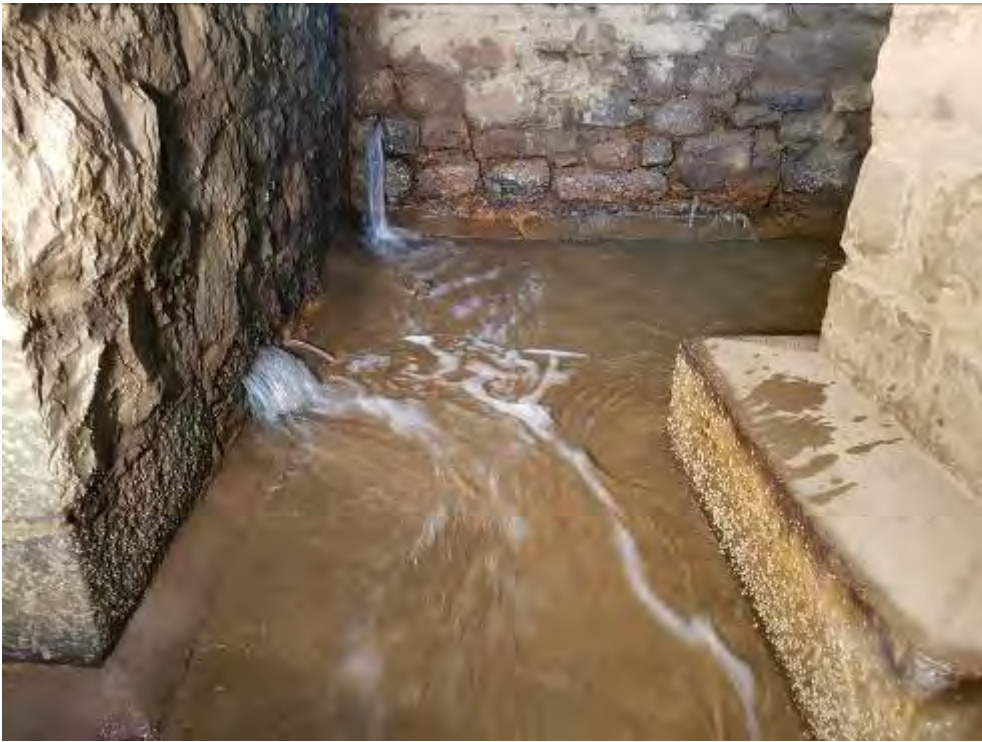
The works required to prevent leakage into the wheelhouse form the most substantial element of the repairs required. Works to prevent leakage within an old masonry dam structure with limited space for the works is challenging and requires specialist geotechnical engineering techniques to remediate. A particular difficulty is the use of concrete grouting where high flow velocities through leaking sections of wall as a result in variations in water levels between the upstream and downstream side of the dam. This can result in washout of grout materials before they can set. This problem can partly be mitigated by draining down the (upstream) pond to reduce the flow of water through the dam structure, however it is not anticipated that measures would be taken to prevent the natural variation of tidal levels on the downstream side of the dam.

Photos showing leakage into the Wheelhouse (Basement)

Atkins has investigated a number of options to reduce the leakage within the causeway, based on a range of construction techniques. This includes an option for resin grouting which has been successfully used to repair old dock walls at Milford Docks even whilst the docks remain in operation. In addition, conventional grouting of the ground has been considered as well as removal and replacement of the impermeable clay core material. The design of the repairs has had to consider sub-surface flows of water which continue to cause erosion as well as repointing repairs to wall masonry. All the options proposed have been costed and compared and will be selected to deliver both an economic solution and one which utilises construction methods sympathetic to the conservation value of the Causeway.
